Innovative Streambank Protection in an Urban Setting, Accotink Creek, VA

by David L. Derrick and Meg M. Jonas

PURPOSE: The goal of this Coastal and Hydraulics Engineering Technical Note (CHETN) is to present the planning, design, construction and 10-year performance evaluation of a comprehensive streambank protection project constructed in an urban watershed (Figure 1). This project used a combination of bendway weirs and longitudinal peaked stone toe protection (LPSTP or stone toe) to protect bridge abutments, stabilize an eroding bank line, and initiate floodplain formation. The project features were adjusted to site conditions to minimize environmental impacts. The project is a good example of the use of bendway weirs and stone toe in combination to provide effective, economical, and environmentally sound streambank protection.

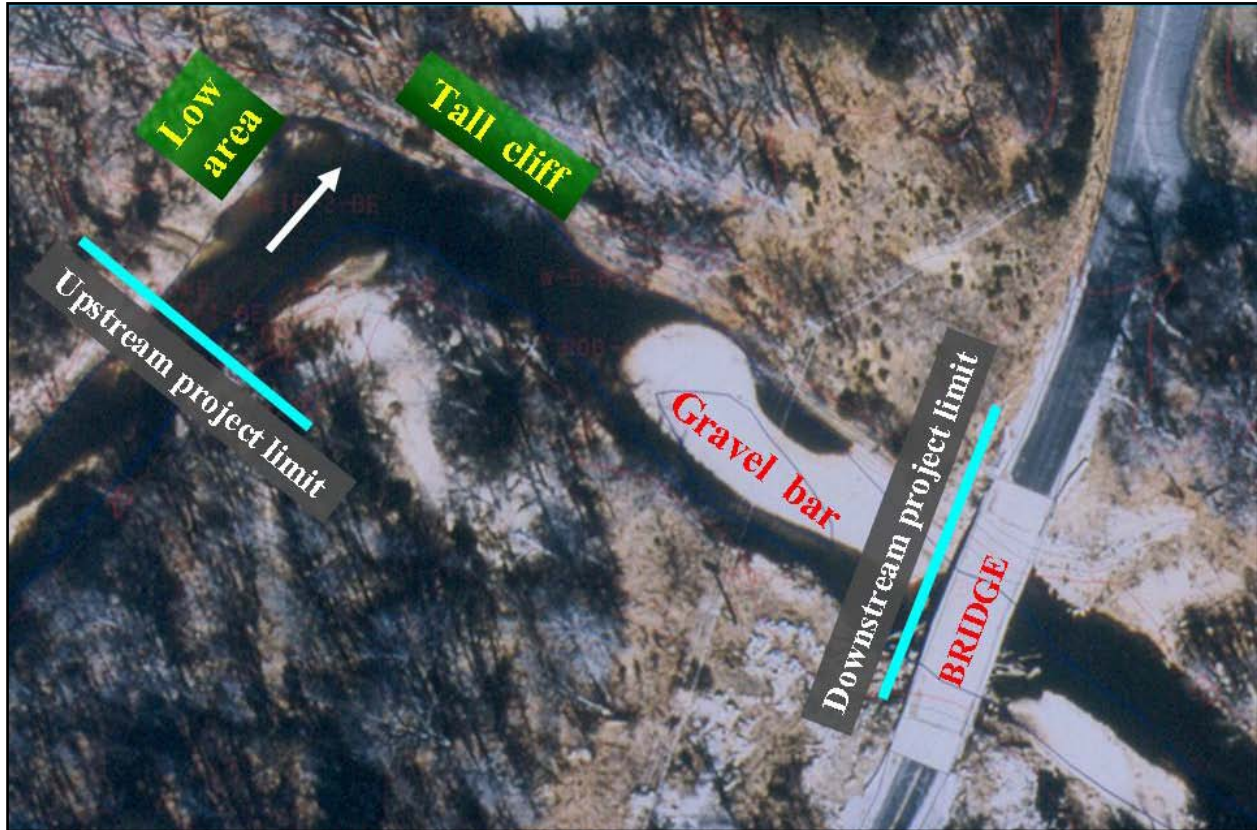
Figure 2. Aerial photograph of project area with project limits, Accotink Creek at Panther Bridge.

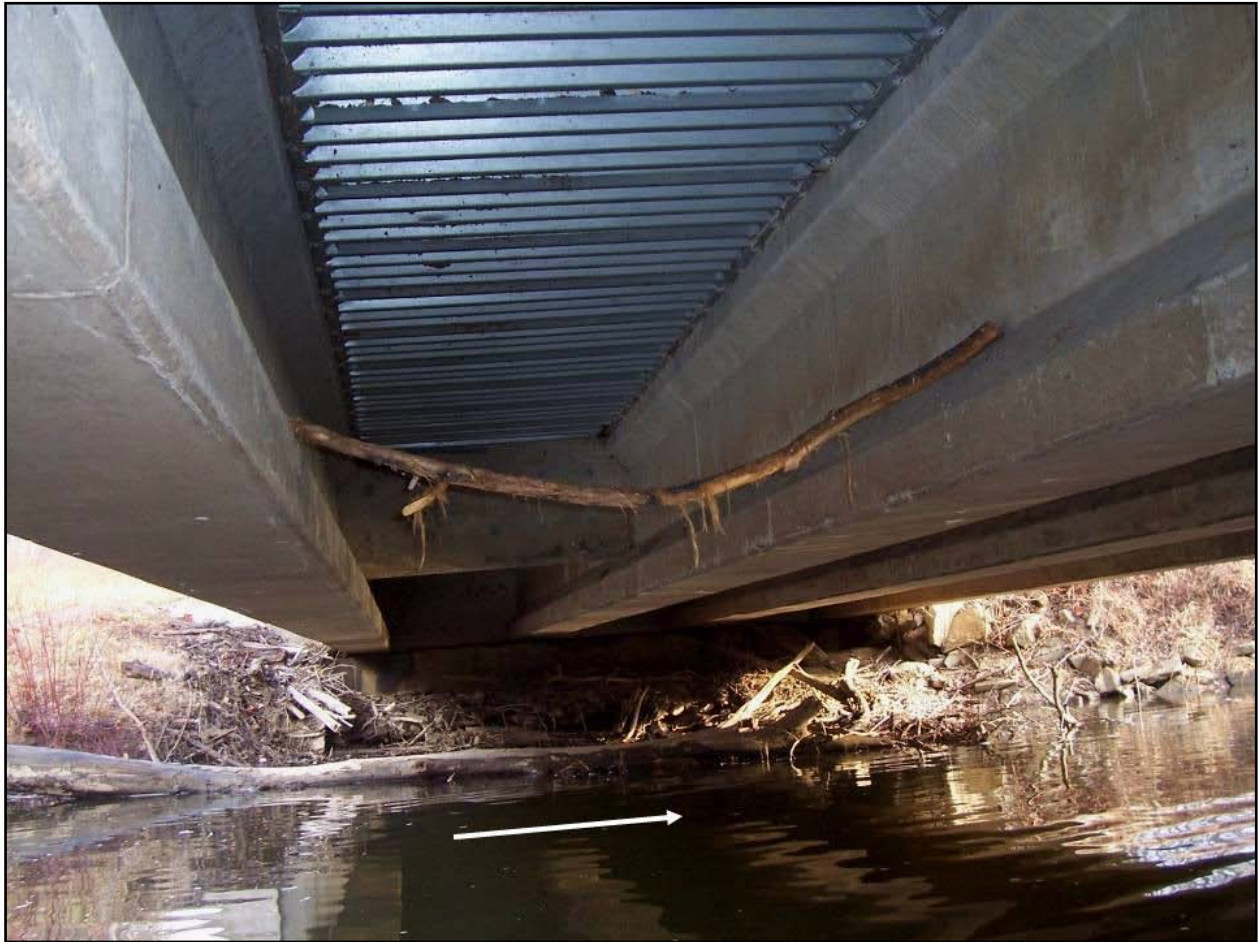
Figure 6. Undersized bridge opening, Panther Bridge at downstream end of project (branch stuck up under bridge).

FLOW ISSUES WITH BRIDGE: Panther Bridge was constructed at a low elevation, and will not pass the 2-year flood (Figure 6). The lowest road elevation is 24.7, while the minimum water surface elevation for the discharge associated with the 2-year storm is 27.6, which results in 2.9 ft of flooding of the road (Sheladia Associates 1996).

The bottom of the bridge girders is typically only 50 in. above the base flow water surface elevation. Due to the undersized bridge opening and the low elevation of the bridge span, maintenance removal of large woody debris has been an ongoing problem. However, since project completion, less debris removal has been required from the bridge abutment (Hudson 2009). This is probably due to improved alignment of the main current through the bridge opening.

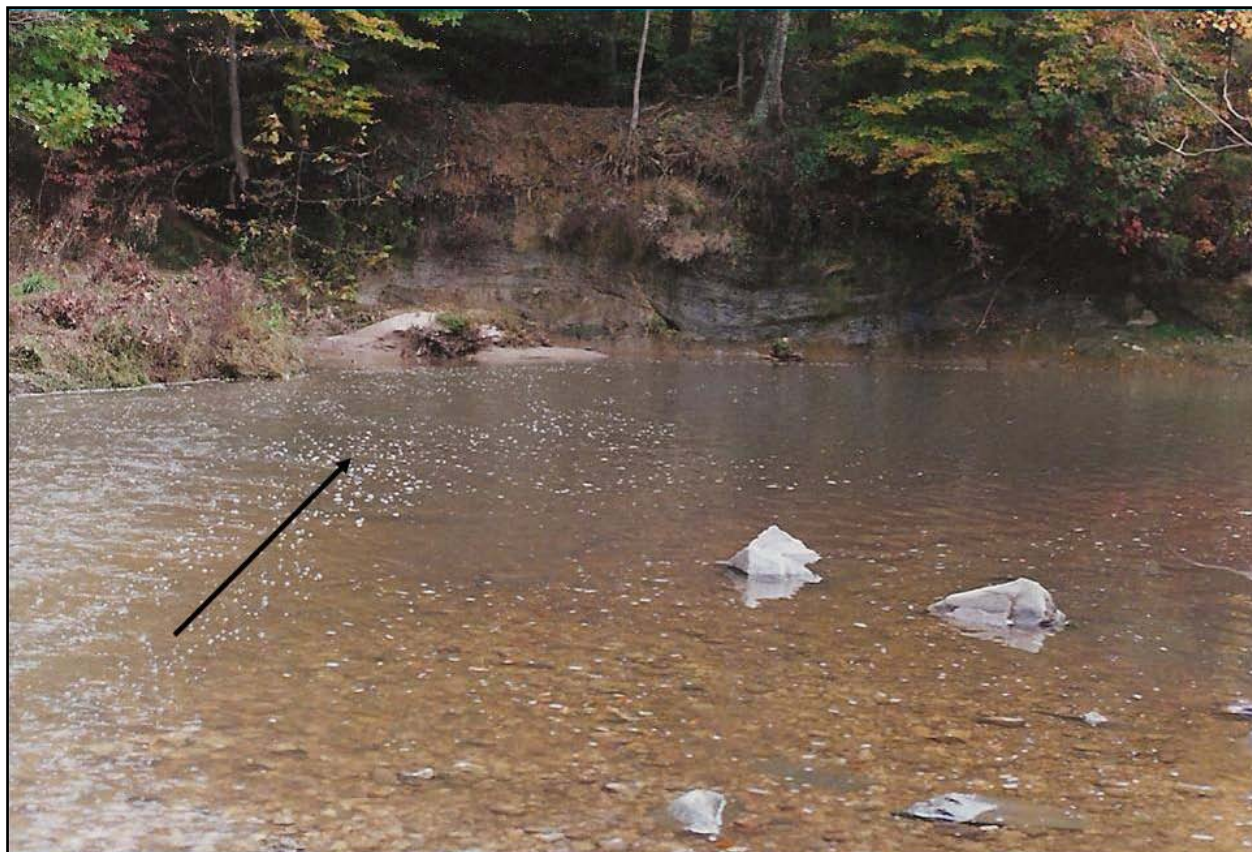
Figure 8. Looking downstream at impinging flow into tall bank area, left descending bank, 25 October 1996.

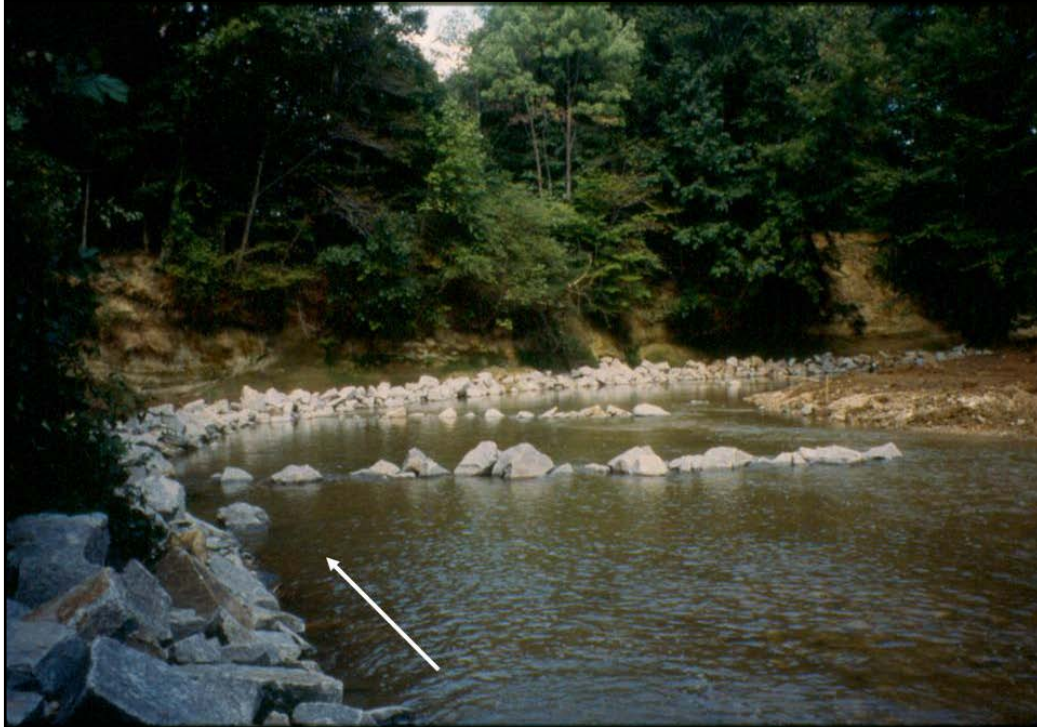
Figure 9. Normal flow, looking downstream at LPSTP and weirs 2 and 3, September 1997 (during construction).

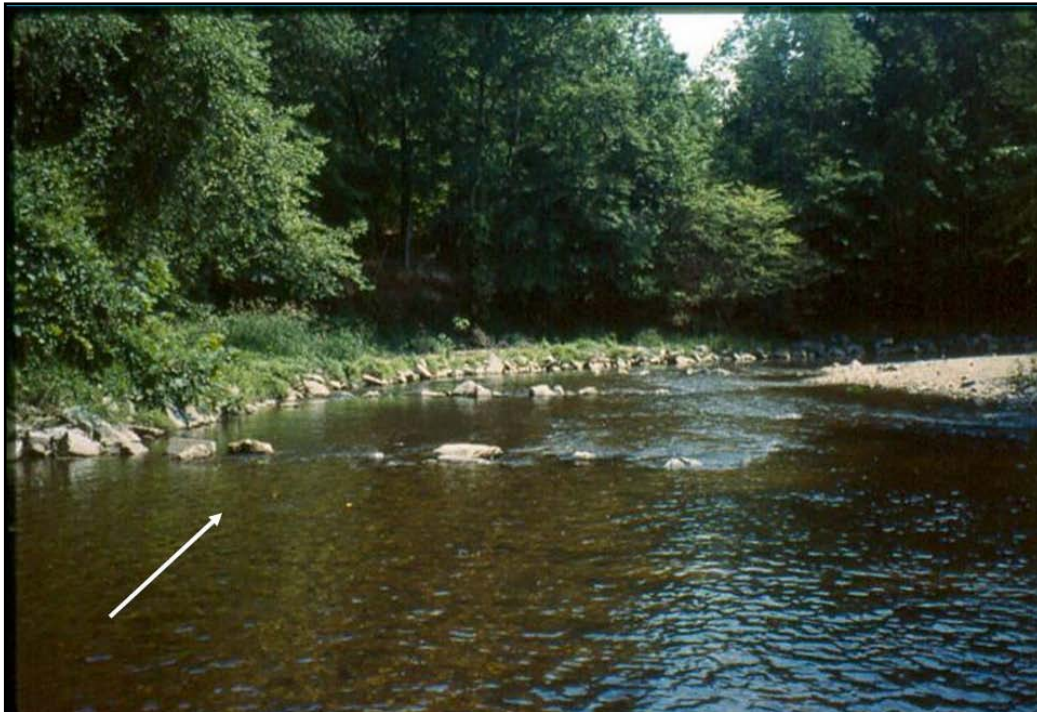
Figure 10. Looking downstream at bendway weirs 1-3, 17 May 2000 (2.75 years after construction).

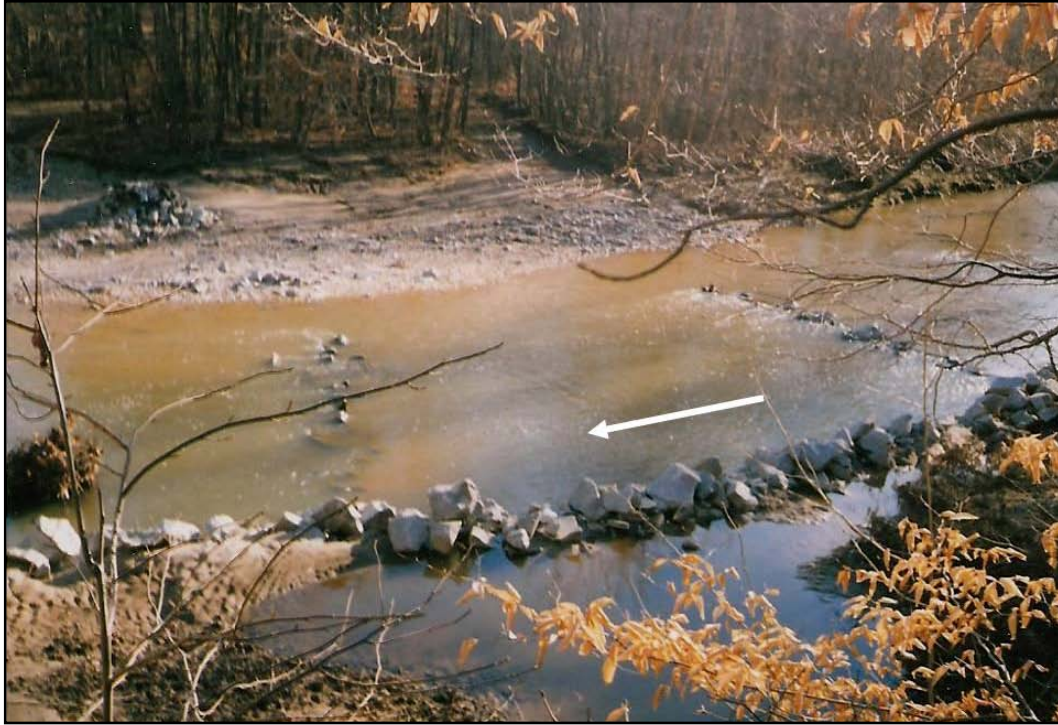
Figure 12. Mid-project from cliff looking at LPSTP and weirs 2 and 3, 1 February 1998 (5 months after construction). Note: low area and water landward of LPSTP.

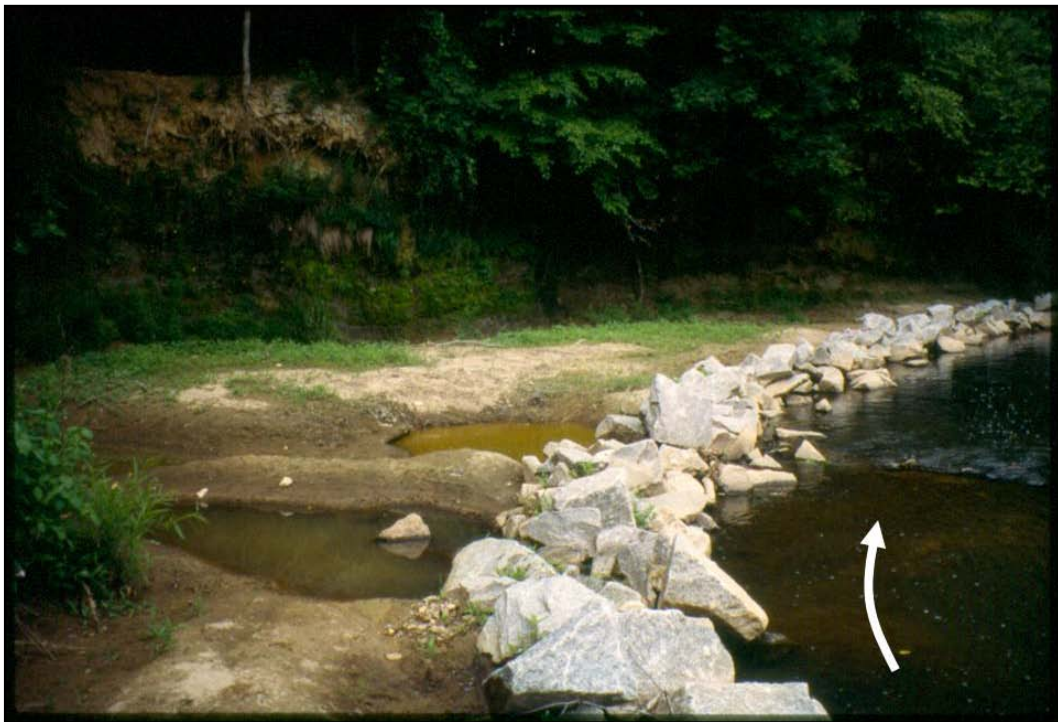
Figure 13. Looking downstream at new deposition landward of LPSTP at weir 3, 8 June 1998 (9 months after construction).

Floodplain Formation. An interesting and successful aspect of this project is the amount of deposition that has occurred on top of, and landward of, the upper 125 ft of the LPSTP, where the false bank line was constructed (Figures 12-14). The channel is depositing sediment and forming a floodplain in the left overbank. In some sections the deposition has built up 4 ft over the LPSTP. This floodplain formation is an unusual feature of this project. One contributing factor is a plentiful supply of sediment. The second factor is the top elevation of the LPSTP (as built) in the false bank line. From experience on other projects, it is known that if the LPSTP is constructed either too high or too low, a floodplain will not form. If the LPSTP is constructed too high, the overbank area is only accessed rarely by the channel flows (similar to a terrace). If the LPSTP is constructed too low, it will be overtopped frequently with high-velocity flows. These will scour sediment from the low overbank area (rather than depositing it). The LPSTP may fail if it is not designed to withstand frequent impinging flows. The height and configuration of the LPSTP false bank line worked well in this situation to “nudge” the channel into building its own floodplain. It is an excellent example of a design that works with the natural tendency of the channel. Further investigation into the factors that caused success here (hydrology, sediment loads, and LPSTP design) would be useful. For instance, the flashiness of the discharge regime in this urban watershed may increase the range of “successful” LPSTP elevations for floodplain formation.

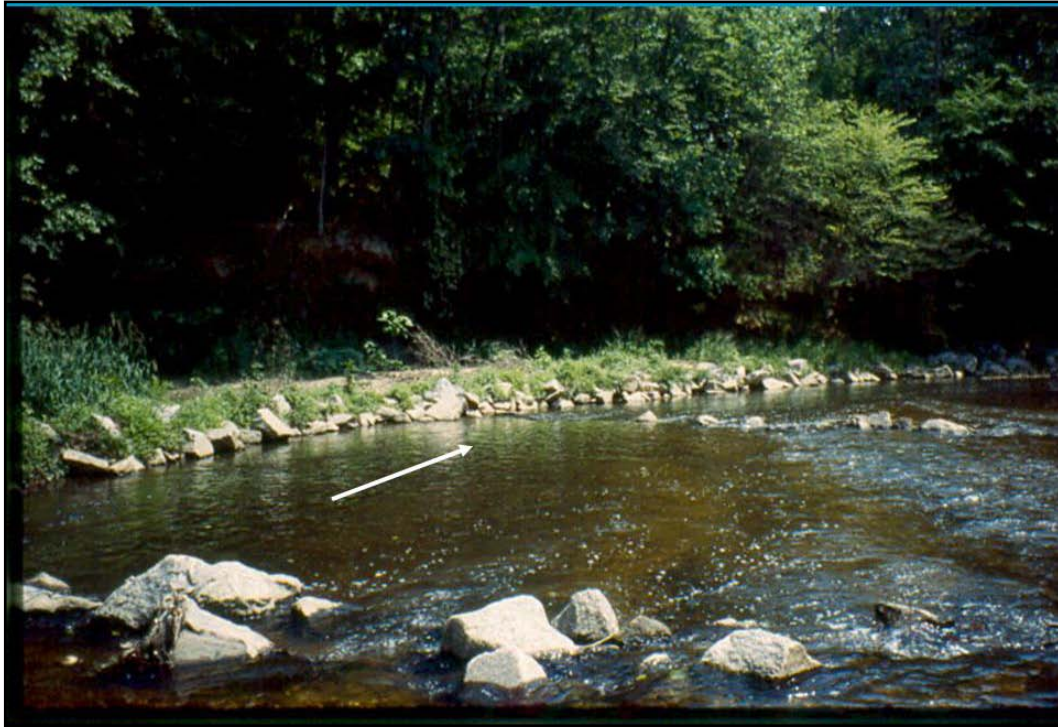
Figure 14. Looking downstream at weirs 2 and 3, 17 May 2000 (2.7 years after construction).

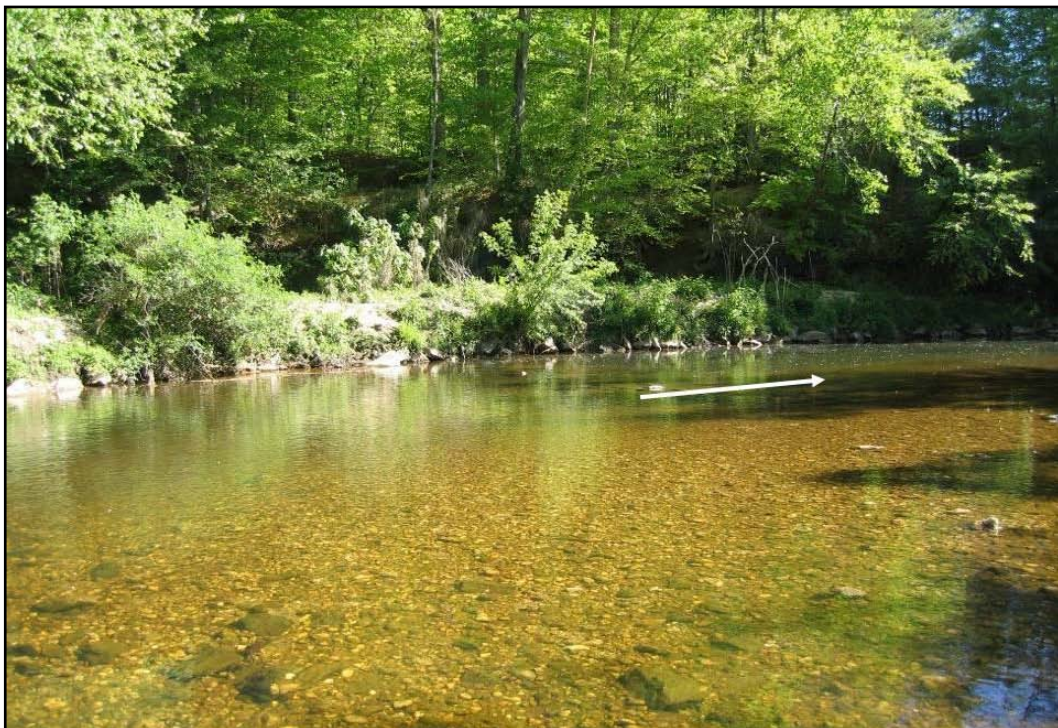
Figure 15. Looking downstream at left bank, 1 May 2006 (8.75 years after construction) 4 ft of deposition on LPSTP with some robust vegetation.

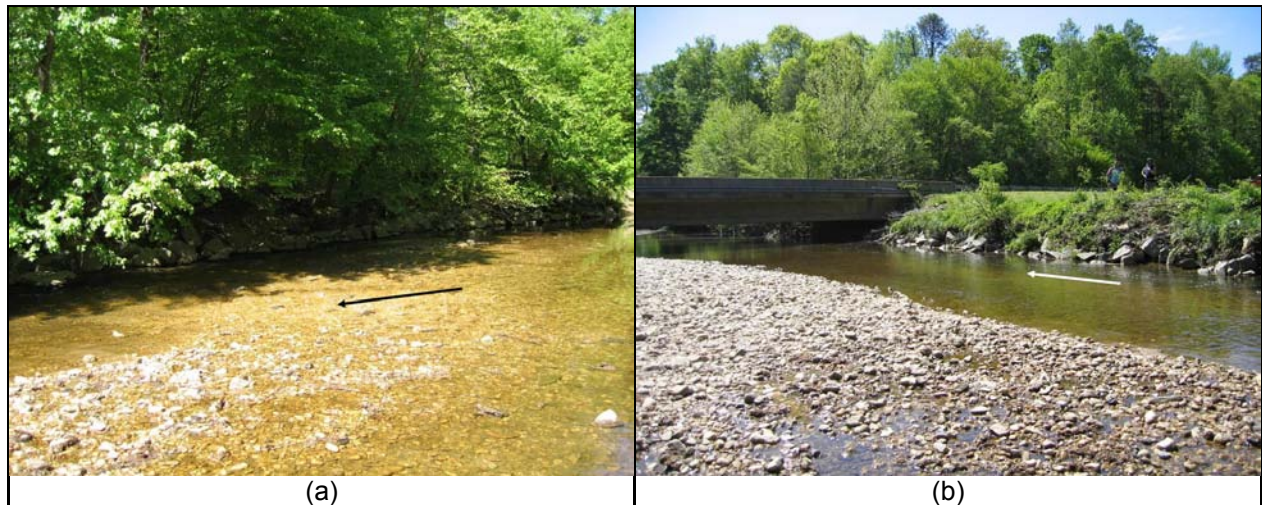
Figure 16. Right descending bank upstream of Panther Bridge, 1 May 2006 (8.75 years after construction). PSTP, mostly hidden, still protecting trees a decade after installation. (a) Looking upstream. (b) Looking downstream.

The right bank LPSTP has effectively provided protection for the right bank, the seven mature trees along the right bank, and the right bridge abutment (Figure 16). The thalweg is usually impinging into the upper section of the LPSTP, and then runs parallel with the LPSTP providing excellent current alignment into Panther Bridge. Even with the stream forces working on this for 10 years, only relatively minor self-adjusting has occurred. The use of stone toe in this section eliminated the need to grade the right bank, and allowed mature riparian vegetation to be saved. No significant retreat of the upper bank has occurred.

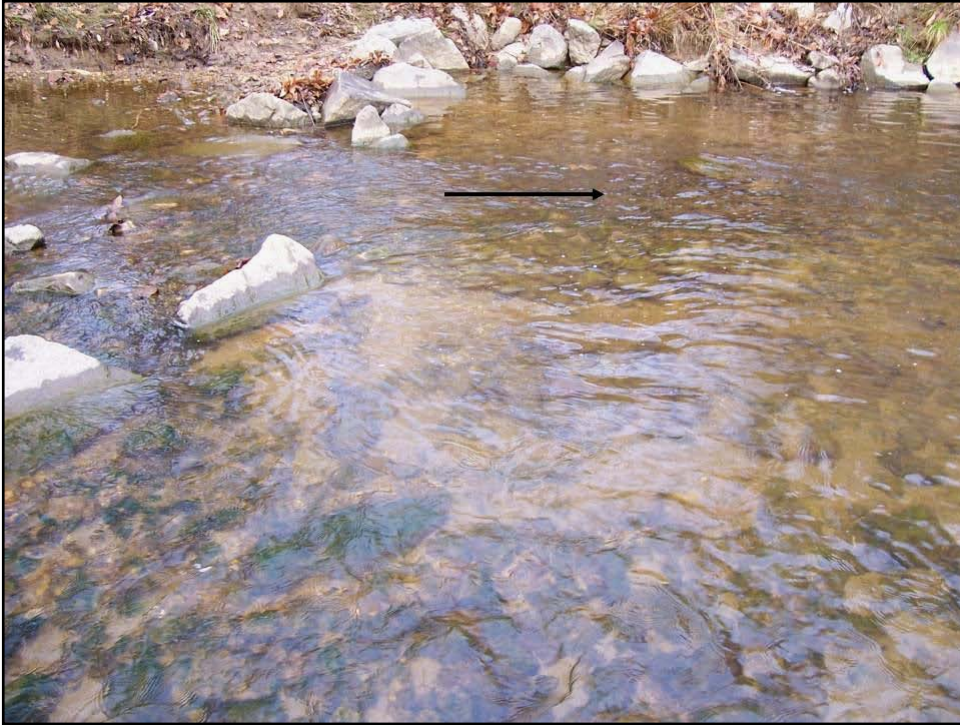
Figure 17. Within weir field bed substrate consists of a diverse mix of gravel, cobble, sand, and leaf litter, 14 January 2008 (10 years after construction).

The bendway weirs have performed as expected. In this project, during high-flow events, velocities are reduced in the weir field, and the thalweg has moved to an alignment at the stream ends of the weirs. In this project, the three upstream bendway weirs (Weirs 1, 2, and 3) were constructed approximately 10 ft too long. This has led to some minor scour of the point bar on the opposite bank (the right bank) since the thalweg has been shifted further to the right than desired. This project was one of the first applications of bendway weirs on a smaller stream. To determine bendway weir length, the required thalweg alignment is determined and laid out on the plan sheet, and the bendway weirs are drawn so that the stream ends of the weirs are located just short of the thalweg location. The additional bendway weir length used in this project has not hindered overall project function greatly. The weir field contains a diversity of depths, velocities, and substrates not found in other sections of the project. The slower velocities allow sediments (sands, silts, gravels and cobbles) to deposit along with leaf litter and detritus (Figure 17).

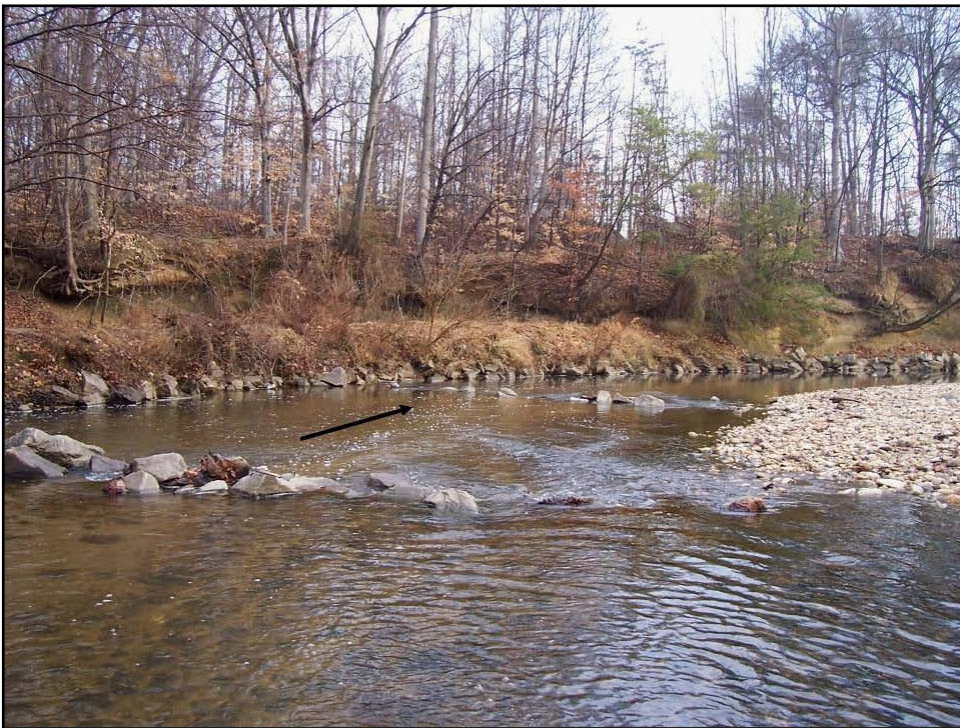
Figure 18. Closer view of stream end of bendway weir 3, 14 January 2008 (10 years after construction). In addition to surface disturbance and aeration there is great diversity and complexity of velocities, depths, and subsubstrate (sand patches within cobble-gravel) within weir field.

Due to the size of stone used, the bendways vary above and below low-flow water-surface elevation, creating mini-blockages and concentrated velocity streams (Figures 18 and 19). In these areas air is entrained into the water column, and turbulence from flow (eddy fences, vortices, return currents, etc.) results in enough fluid movement and modulation to provide “hydraulic cover” for fish.

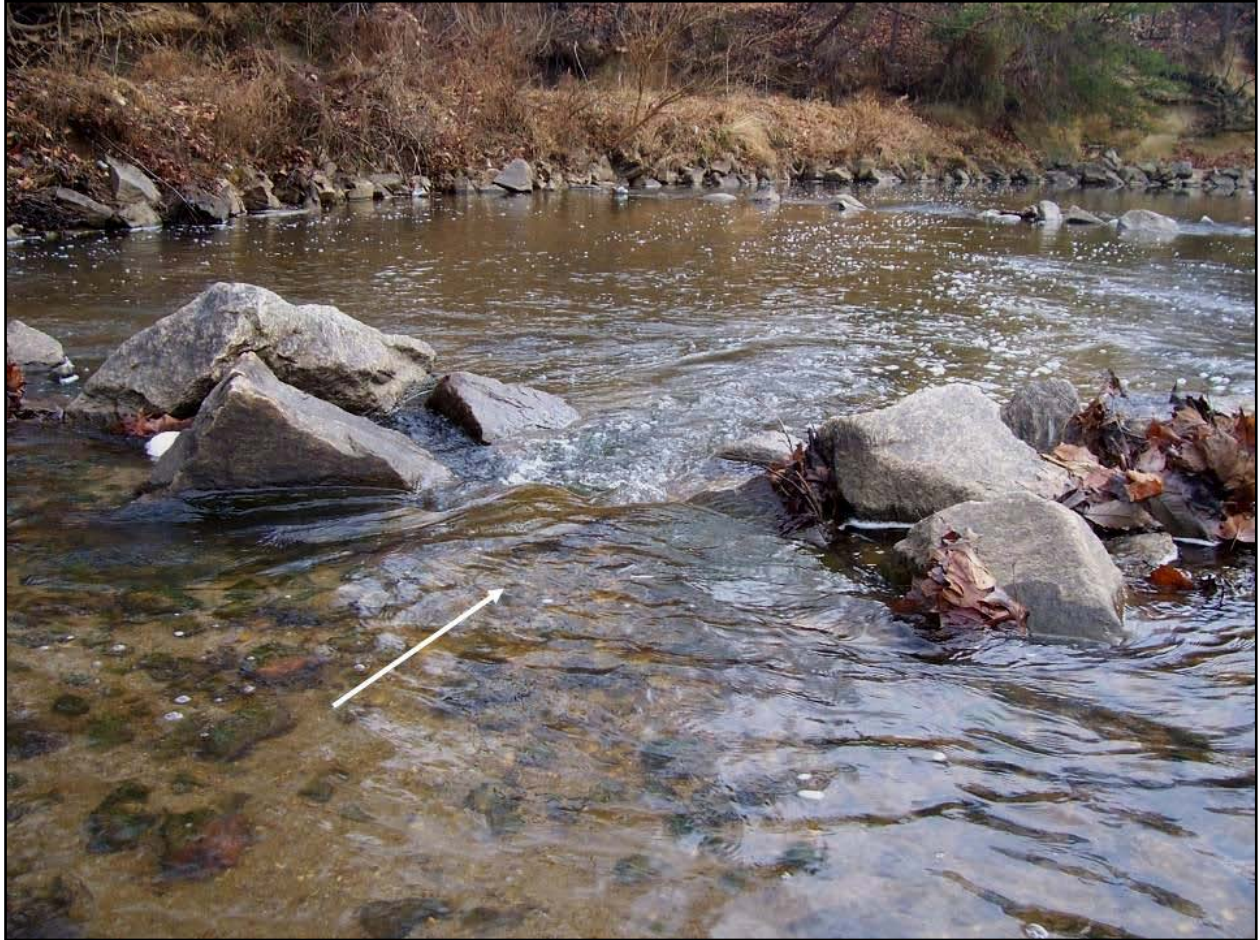
Figure 19. Close-up of crest of bendway weir 2, 14 January 2008 (10 years after construction). Mini plunge pool, aeration, structure, hydraulic cover and solid stable substrate for benthic invertebrates.

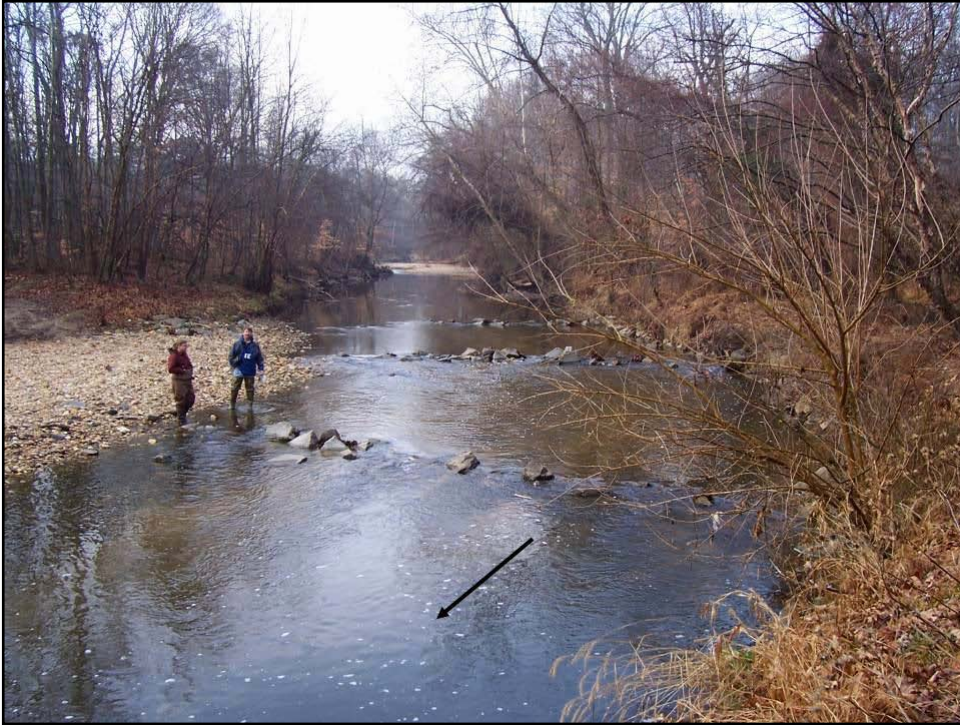
Figure 20. Looking upstream at bendway weirs 1-3 (10 years after project completion, 14 January 2008). Banks are stable.

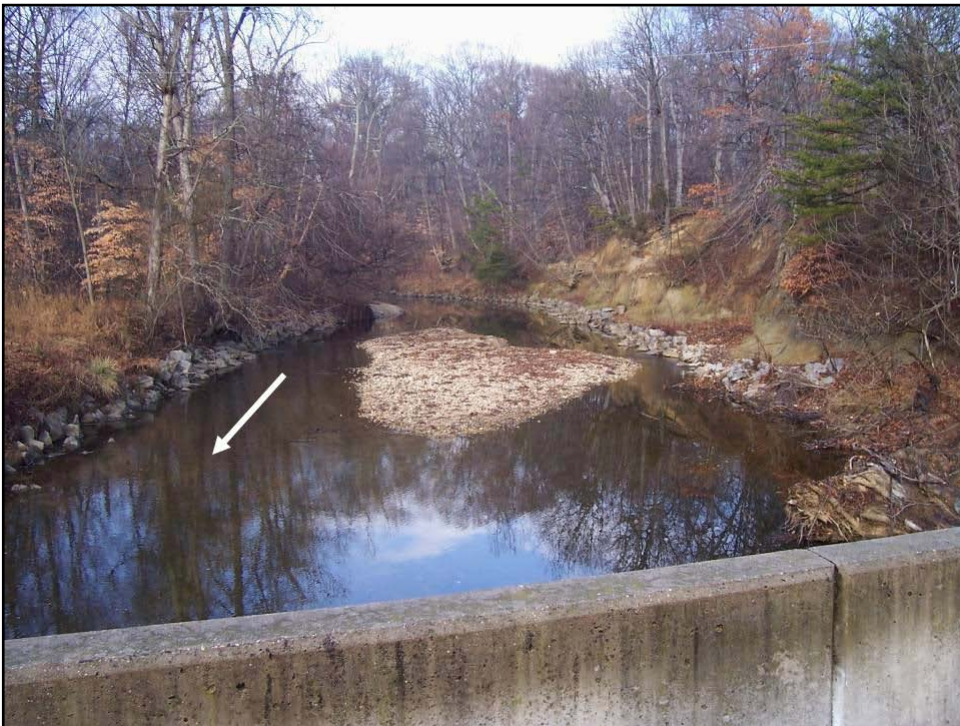
Figure 21. Looking upstream from Panther Bridge. Both banks are stable (10 years later, 14 January 2008).
